Manhole Inspection Summary

Manhole # S35QQ_003MH

Insp Date: 1/22/07 12:39 PM

Location Address: **300 25 1/2 ST**

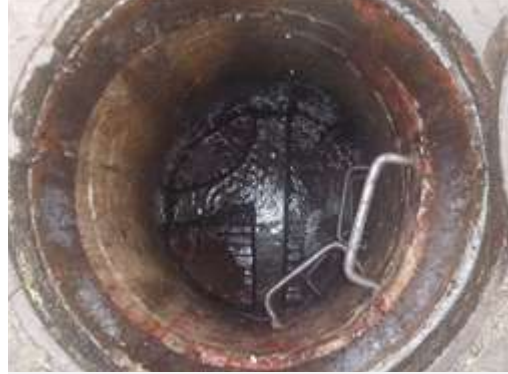
Top View

☒ **Debris** (not Condition related)

☒ **Evidence Of Surcharge**

Evidence of surcharge - Bench debris.

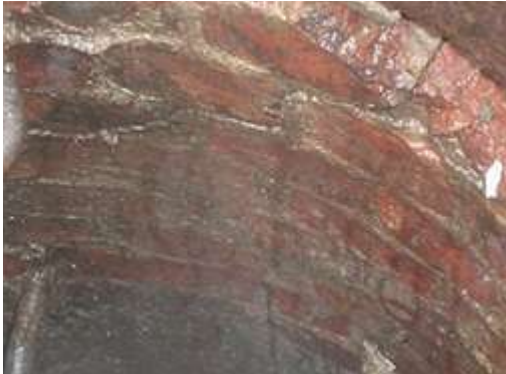
Defect

☒ **Leaks**

Condition: ☐ Sound ☐ Cracked ☐ Root Intrusion ☐ Loose Brick ☒ **Deteriorated**

Infiltration: ☐ None ☒ **Joint** ☐ Cracks ☐ Mortar ☐ Roots ☒ **Wall**

Frame leaks. Adjustment deterioration and infiltration.

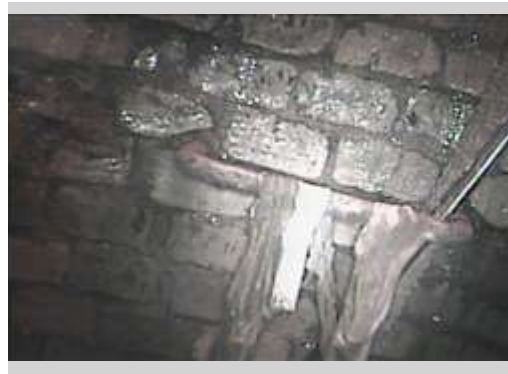
Defect

Depth: **4** (ft.) ☐ Active Surcharge Present

Evidence of surcharge.

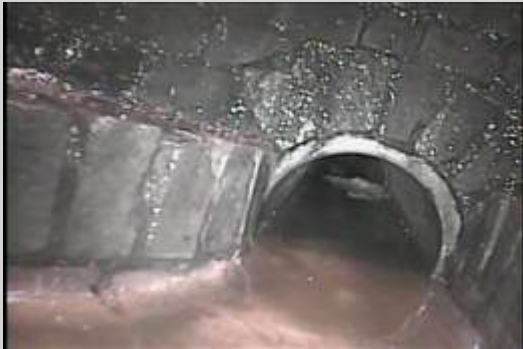
8 in. Circular Gravity Sewer Pipe Out @ 12 O'Clock

Comments **There is active infiltration in the Barrel.**

Barrel infiltration (Active).

Deposits: ☐ None ☒ **Mud** ☐ Sludge ☒ **Debris** ☐ Grease

Silt Depth: **0.5** (in.) Deposits Extent: **Light**

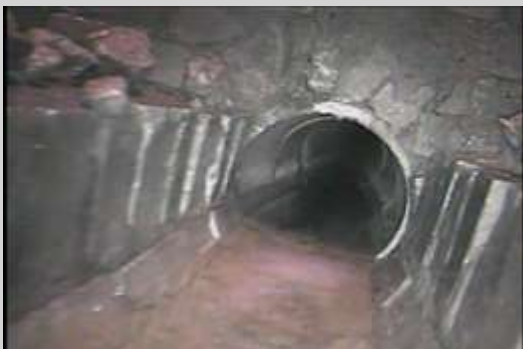
8 in. Circular Gravity Sewer Pipe In @ 6 O'Clock

Condition: ☐ Sound ☐ Cracked ☐ Root Intrusion ☐ Loose Brick ☒ **Deteriorated**

Infiltration: ☐ None ☐ Joint ☐ Cracks ☐ Mortar ☐ Roots ☒ **Wall**

Condition: ☐ Sound ☐ Cracked ☐ Root Intrusion ☒ **Deteriorated** ☐ Leaks ☐ Debris

Barrel deterioration and infiltration. Channel deterioration.

Deposits: ☐ None ☒ **Mud** ☐ Sludge ☒ **Debris** ☐ Grease

Silt Depth: **0.5** (in.) Deposits Extent: **Light**

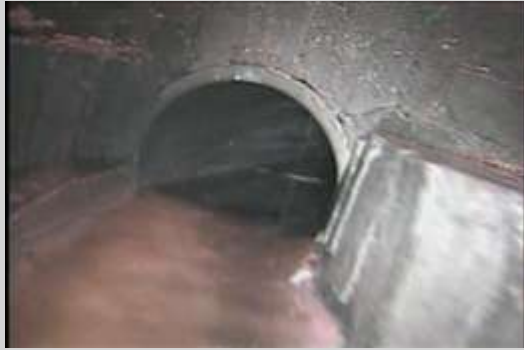
8 in. Circular Gravity Sewer

Deposits: ☐ None ☒ **Mud** ☐ Sludge ☒ **Debris** ☐ Grease

Silt Depth: **0.5** (in.)

Pipe Seal Cond: **Cracked**
